ENGINEERING STUDY AND RECOMMENDATIONS

**ROADWAY IMPROVEMENTS
STONY BROOK SUBDIVISION
GORHAM, NH**

Prepared for:
Town of Gorham

Project #2009-079

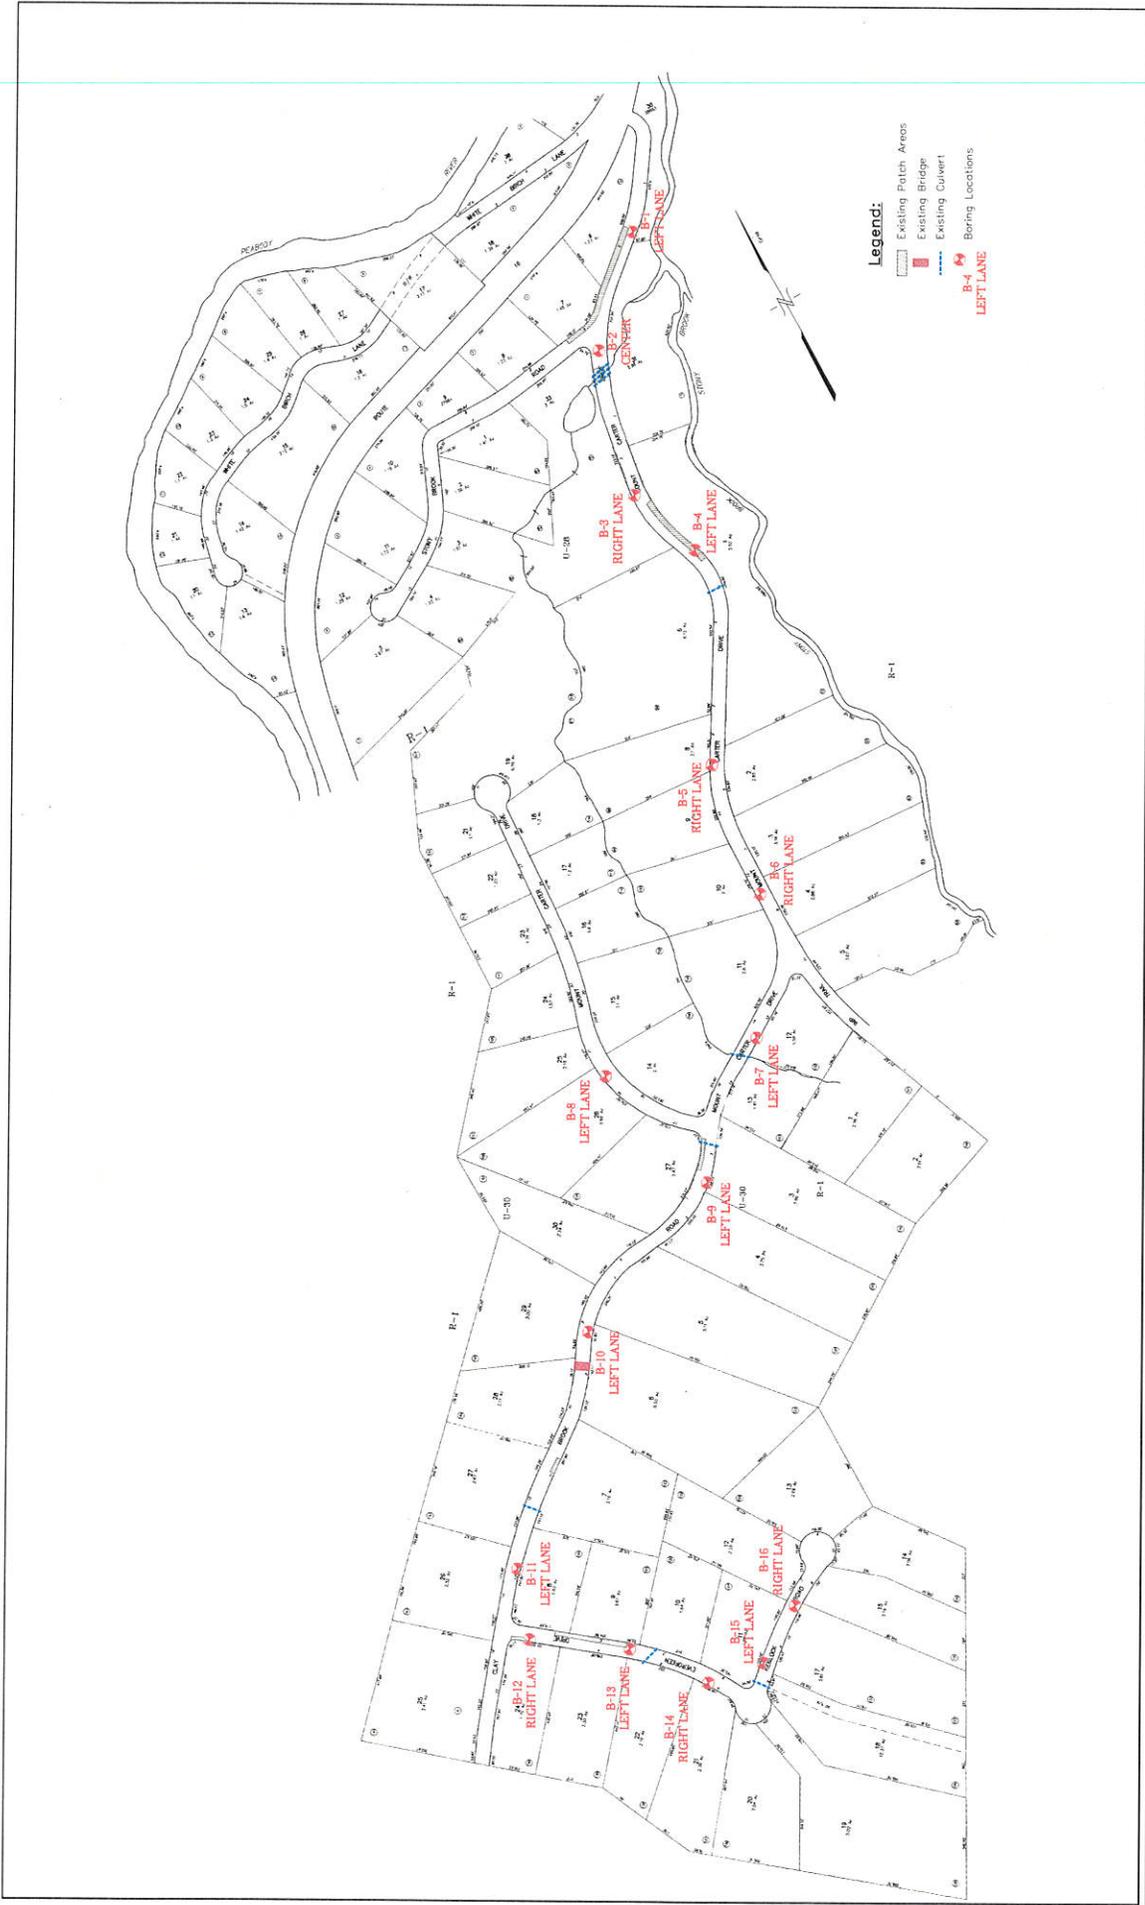
2009-079
C1.01
SHEET 1 OF 1

The locations of the explorations are shown on the plan entitled Roadway Investigation Plan, dated September 21, 2009, prepared by H.E. Bergeron Engineers, Inc. included in Appendix A.

Roadway Investigation Plan
for the
Stony Brook Subdivision
prepared for
Town of Gorham, New Hampshire

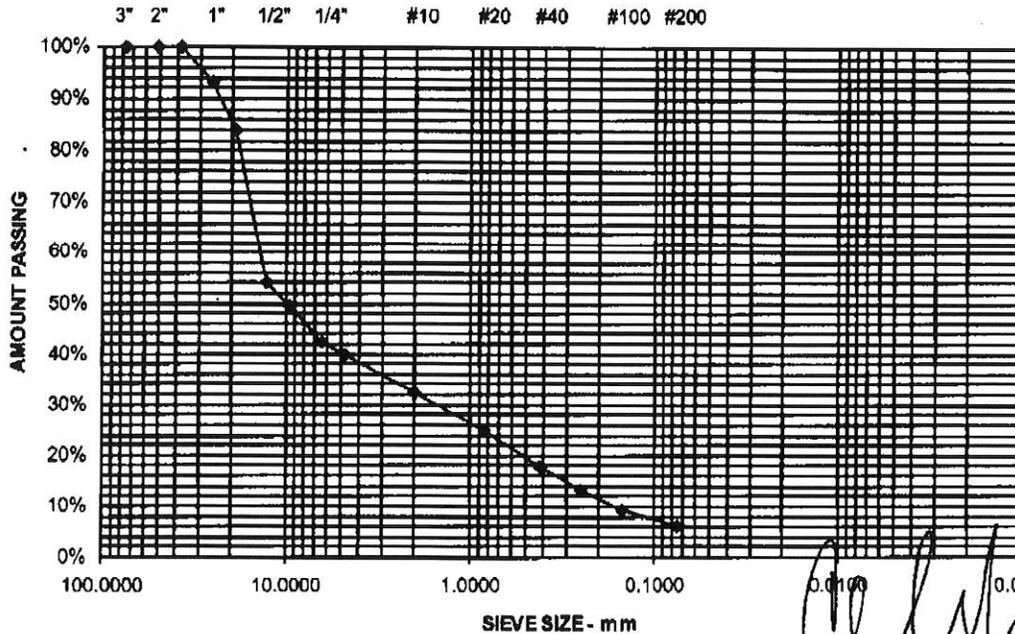
Report of Gradation

Project Name GORHAM NH - STONY BROOK SUBDIVISION ROAD EVALUATION -
 GEOTECHNICAL ENGINEERING SERVICES
 Client H. E. BERGERON ENGINEERS, P.A.
 Material Type 1.5-INCH MINUS SAND AND GRAVEL SOME SILT
 Material Source B-4, BASE,

| STANDARD DESIGNATION (MM/UM) | SIEVE SIZE | AMOUNT PASSING(%) | NHDOT 304 2 GRAVEL - Specifications (%) | NHDOT 304 3 CR GRAVEL Specifications (%) |
|---|---|---|---|--|
| 75 um | No. 200* | 14.7 | 0 - 12 † | 0 - 12 † |

† SAMPLE DOES NOT MEET SPECIFICATION
